ALLIANCE INSPECTIONS
MOLD & MOISTURE

Confidential Mold & Moisture Report

**1234 Anytown Place
Los Angeles, CA. 90000**

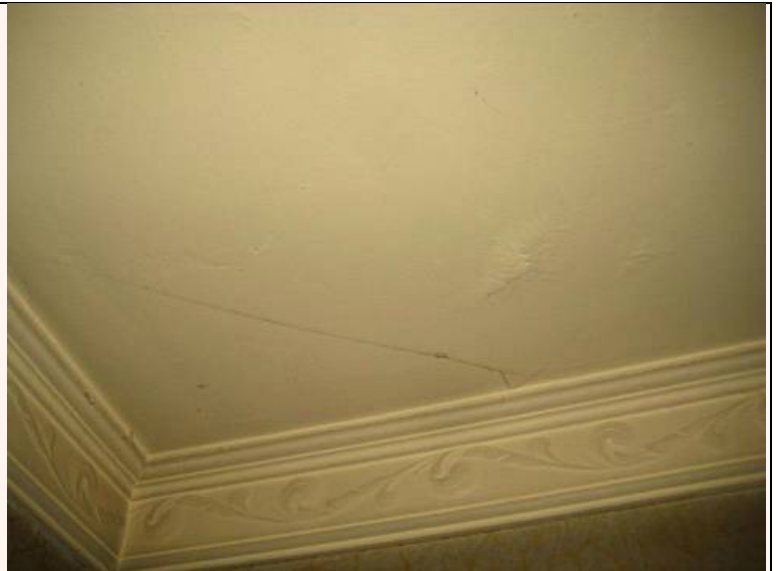
Ceiling:

Signs of water damage throughout house but no moisture on ceiling found.

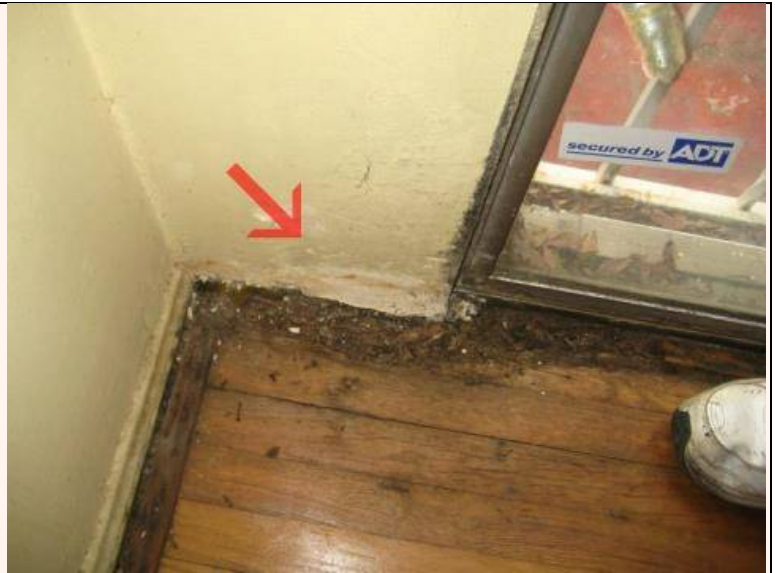
Floor:

Moisture damage on floor and wall.

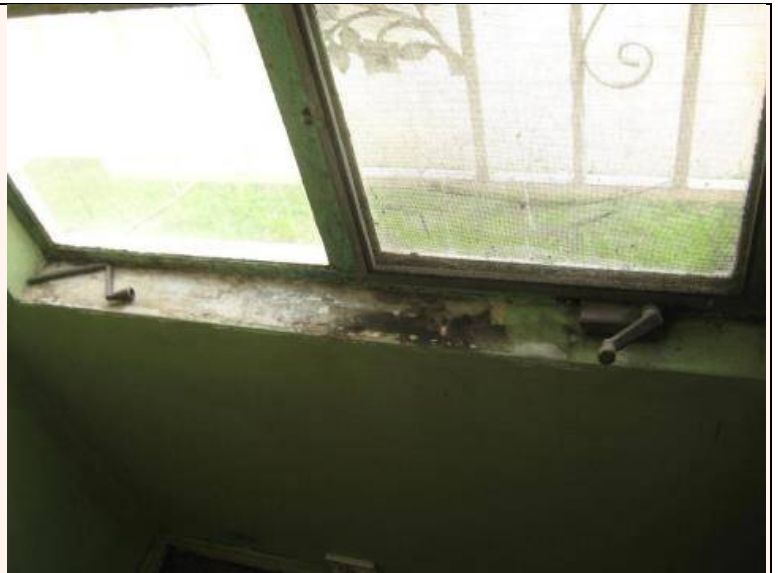
Windows:

Window shows water damage.

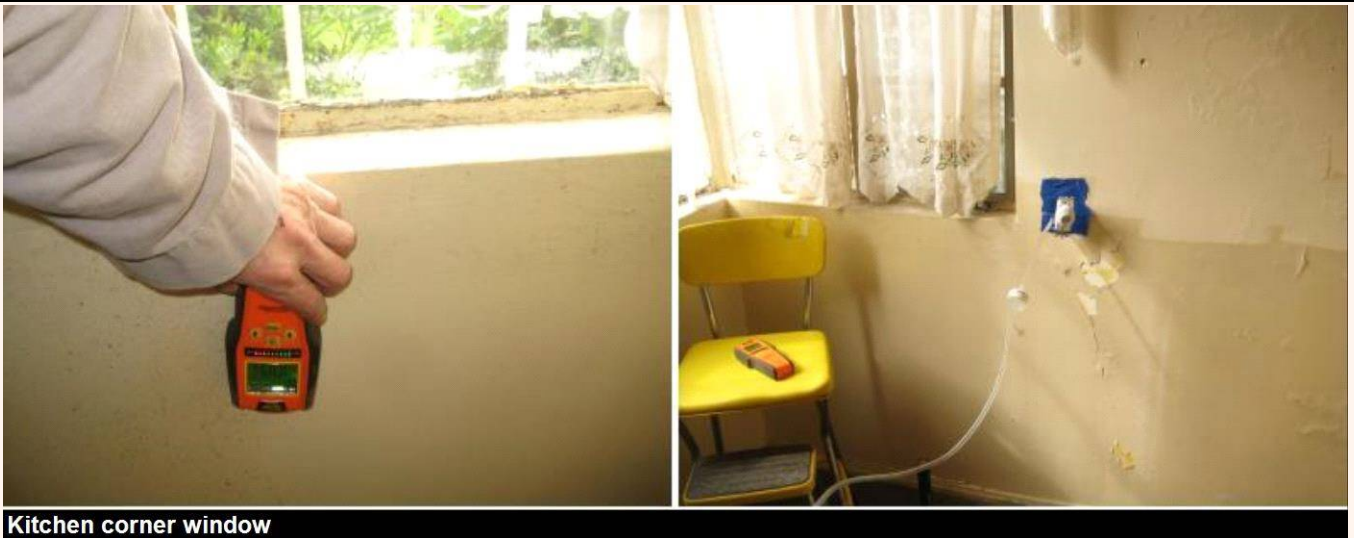
Kitchen corner window

Below the corner window registered a high level of moisture.

Air sample taken from the wall.

High levels of Cladosporium, Penicillium/Aspergillus types, and Stachybotrys were found.

Recommend destructive investigation and abatement of affected areas. Unknown how much of the walls are affected without destructive visual examination.

Standard mold remediation actions are recommended to deal with this damage and mold contamination. A specific protocol can be provided if needed, but the proper protocol is well known to mold remediation personnel using the IICRC S520 Standard and Reference Guide for Professional Mold Remediation.

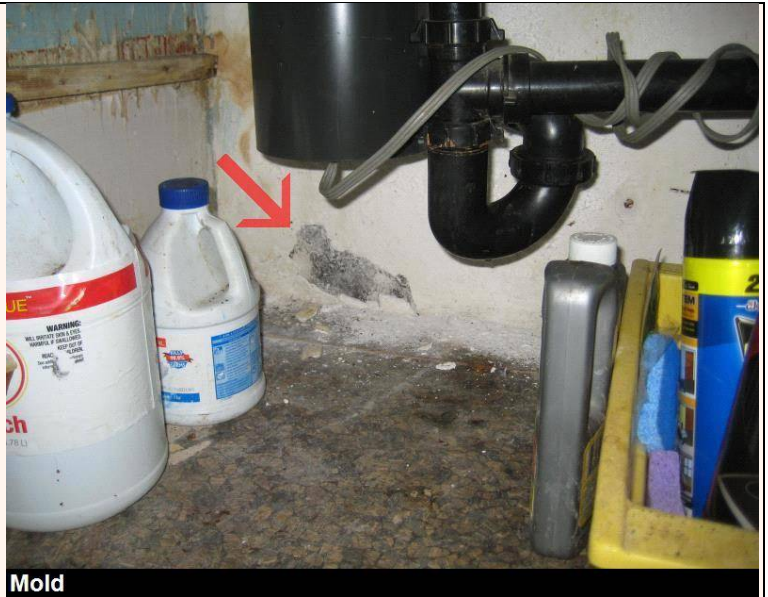
SINK & DRAIN:

Black growth that appears to be mold under kitchen sink.
It is my understanding the cabinets are to be replaced. Recommend further visual inspection behind cabinet and drywall for more mold before installing new cabinets.

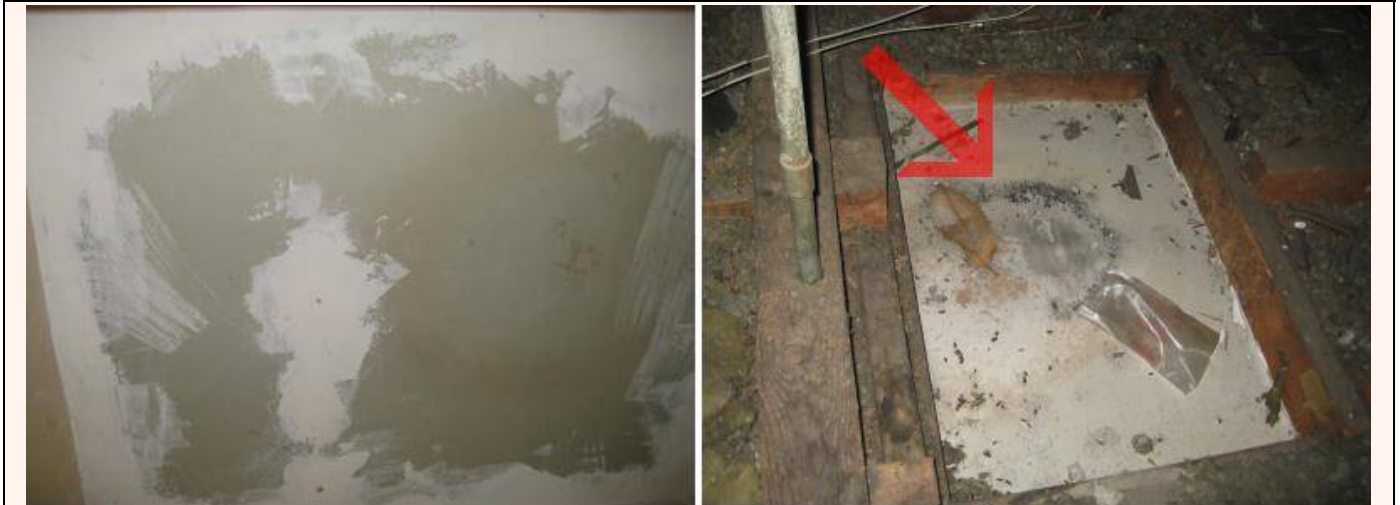
Kitchen pantry has drywall ceiling. Attic side has a black growth. Remove and replace.

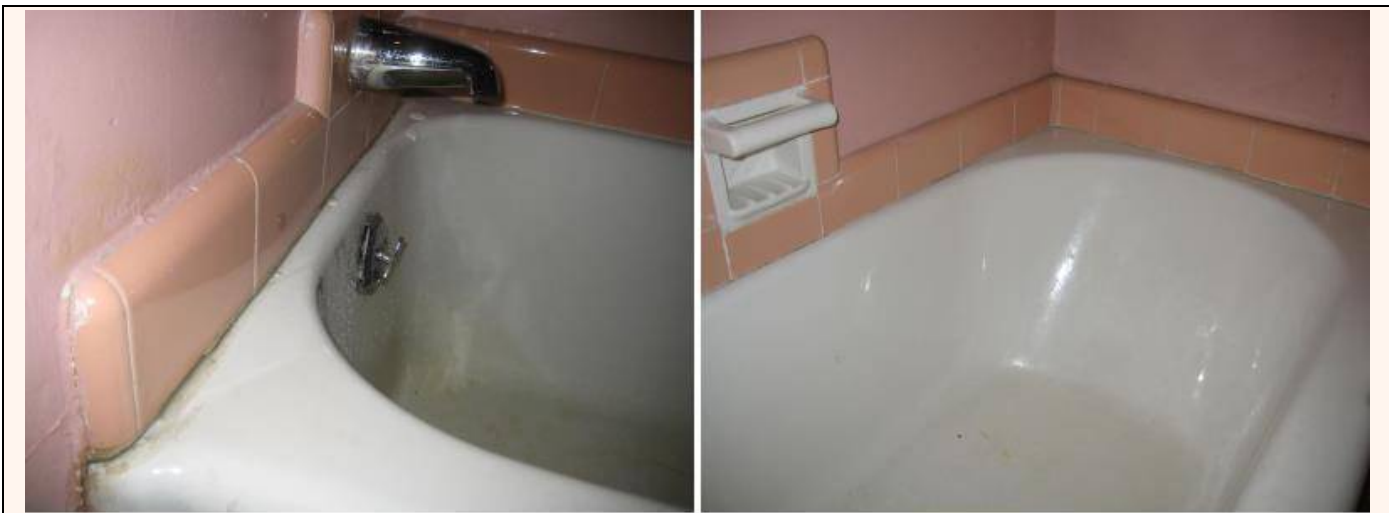
Tub needs silicone between tile and tub.

Shower has mildew growth on ceiling.
Recommend cleaning.

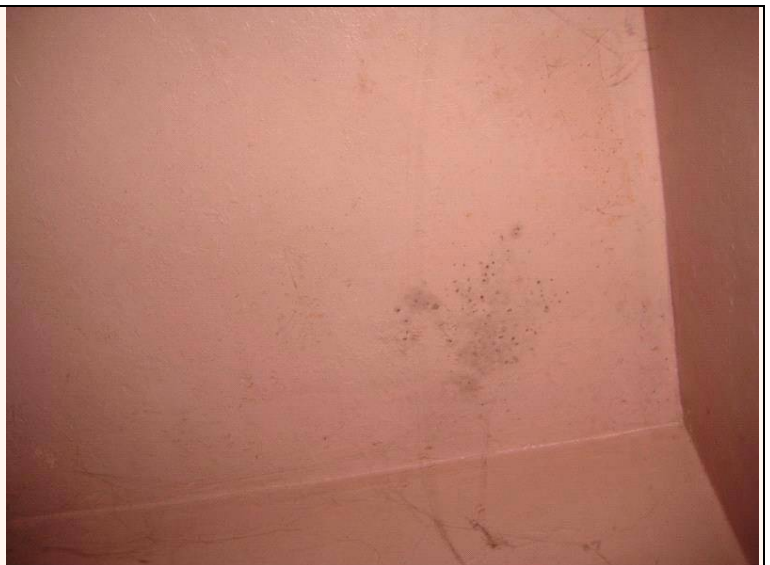
Shower should be cleaned of any mildew or mold on tile.

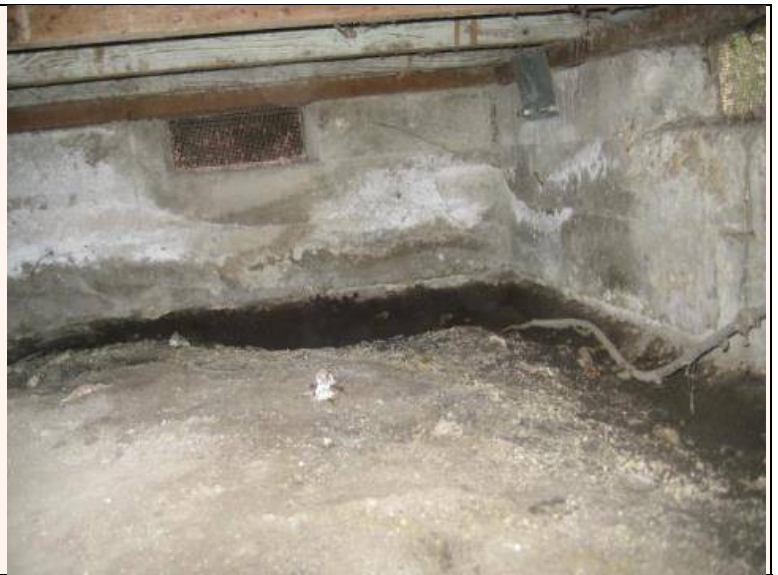
Efflorescence (This is the white chalk like substance) is seen on areas of concrete indicating past water infiltration. Corrections are needed to adjacent grade as this can promote decay.

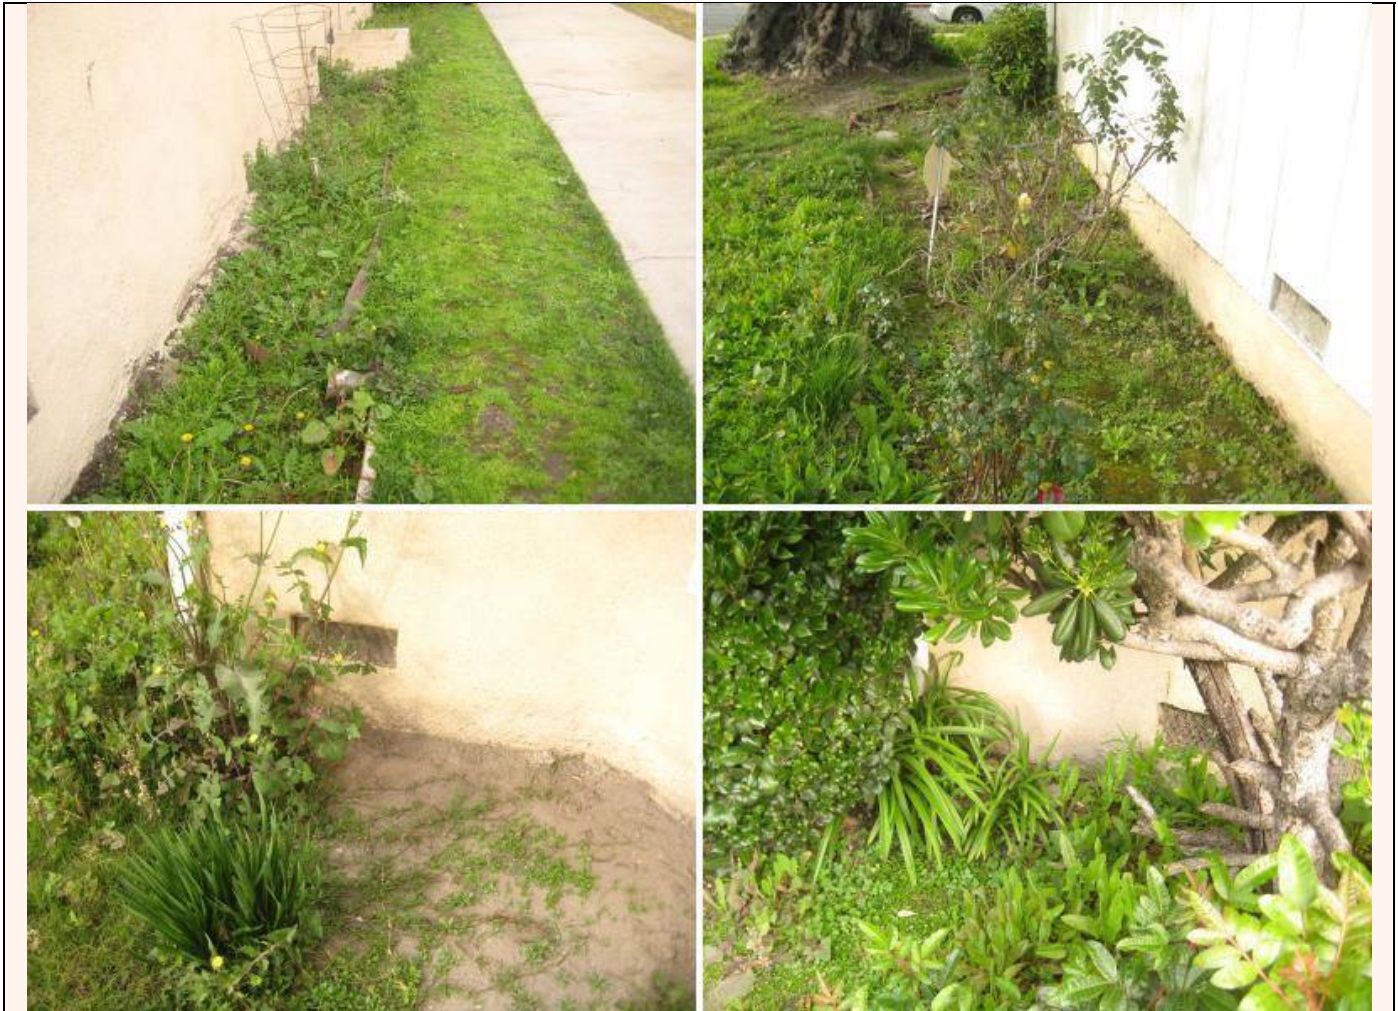
ADJACENT GRADE:

Drainage around the foundation should slope away from the foundation at a rate of 1/2 inch per foot for 6 feet away from the foundation. Portions of the ground around the perimeter do not meet this minimum standard.

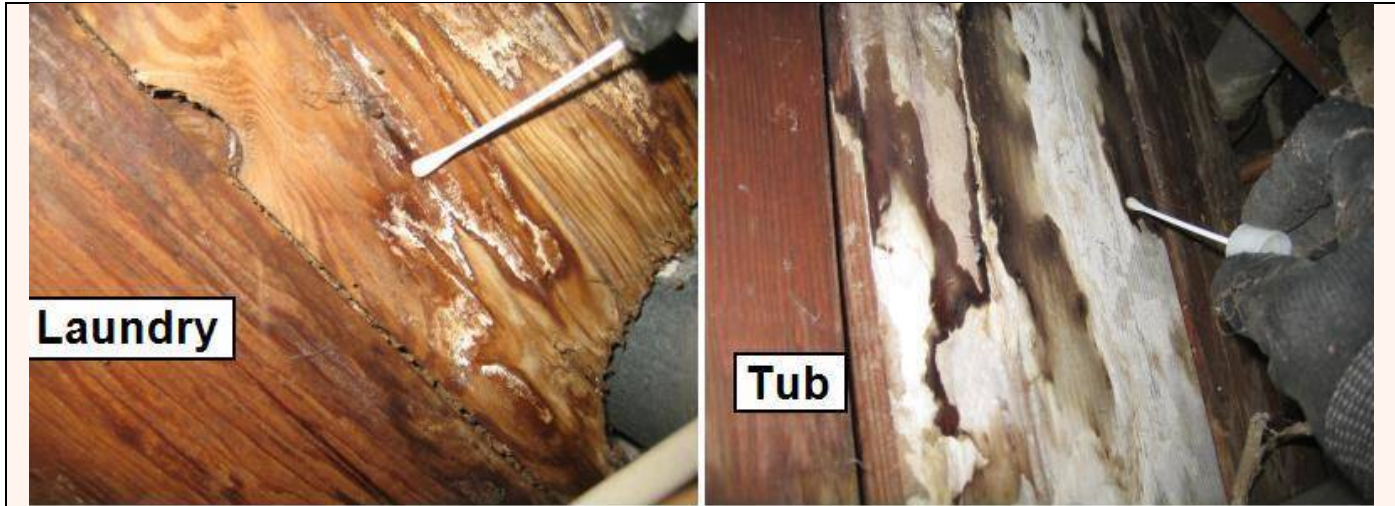
SUB FRAMING:

Water staining noted in areas, such as under bathrooms and kitchen.
Swab sample taken. Low level of *Penicillium/Aspergillus* mold detected under laundry, nothing under tub.

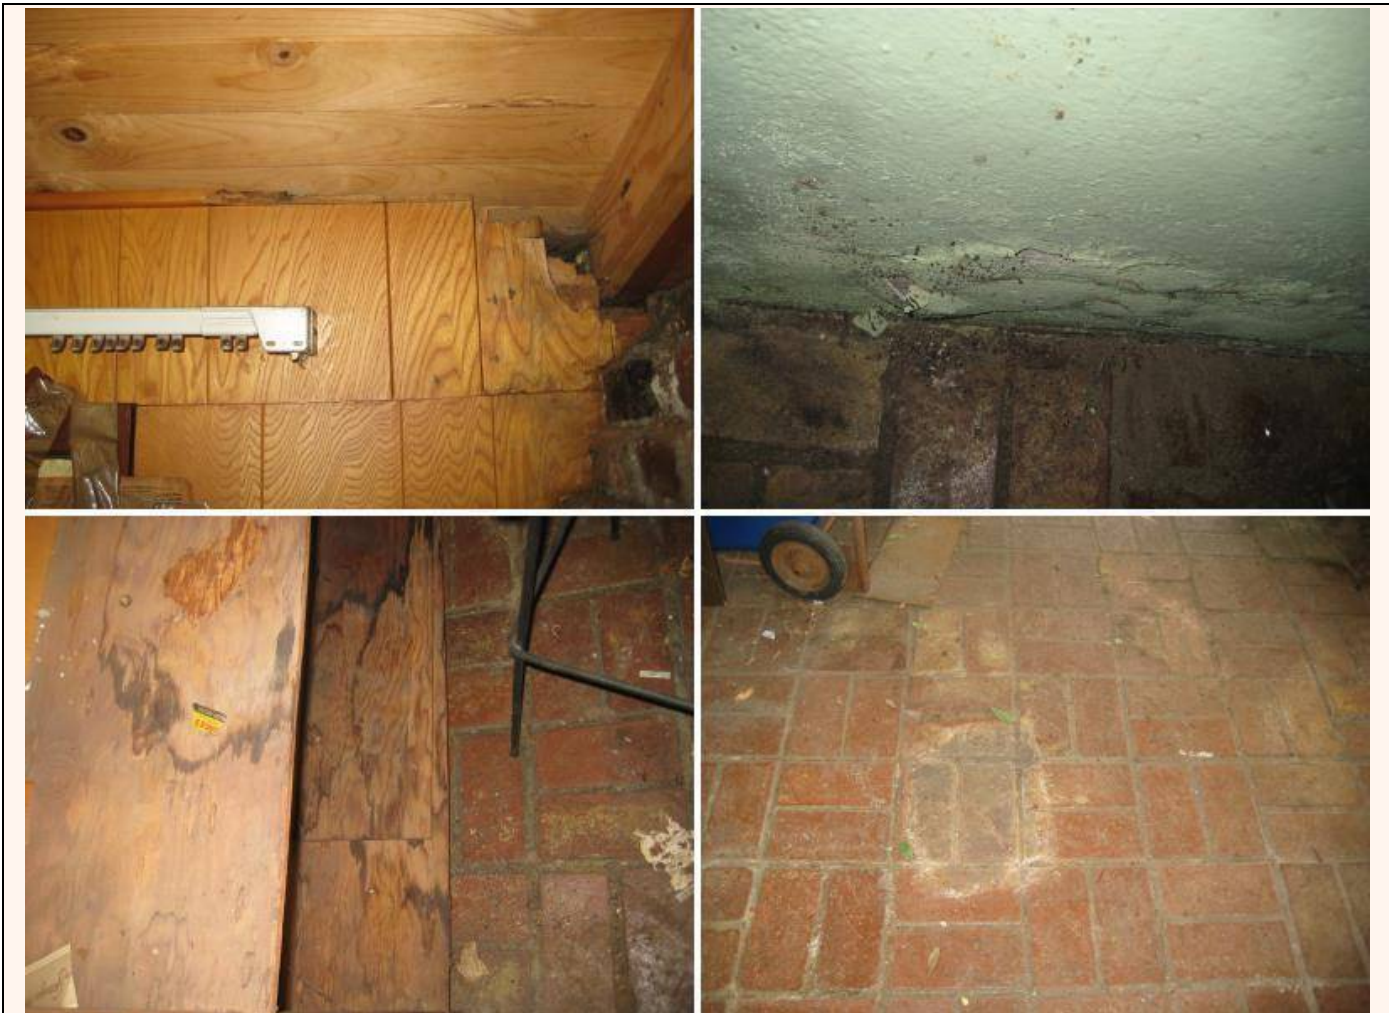
Garage is detached and free standing, converted to a room.
Multiple signs of water intrusion.
Recommend not using as a living or work space.

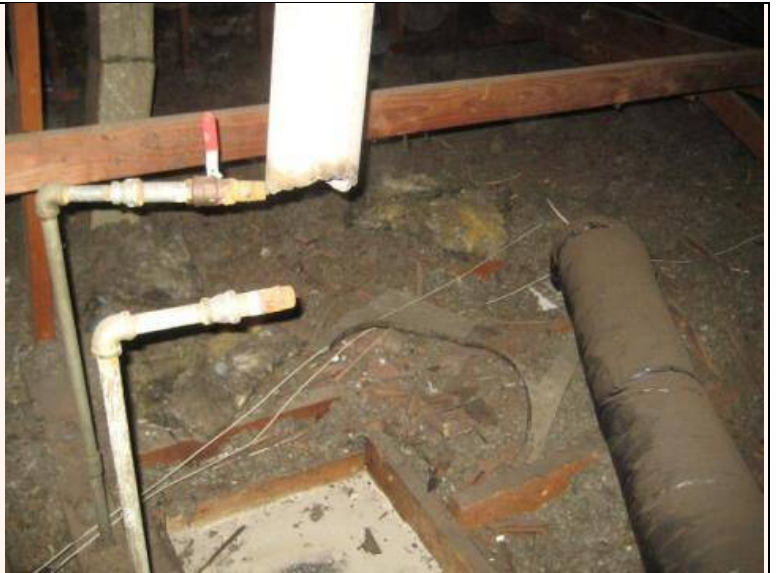
Attic cavity was inspected by entering the area. A leak is created by this pipe which is dripping on the drywall in the kitchen cubby. Recommend repair by a roofer.

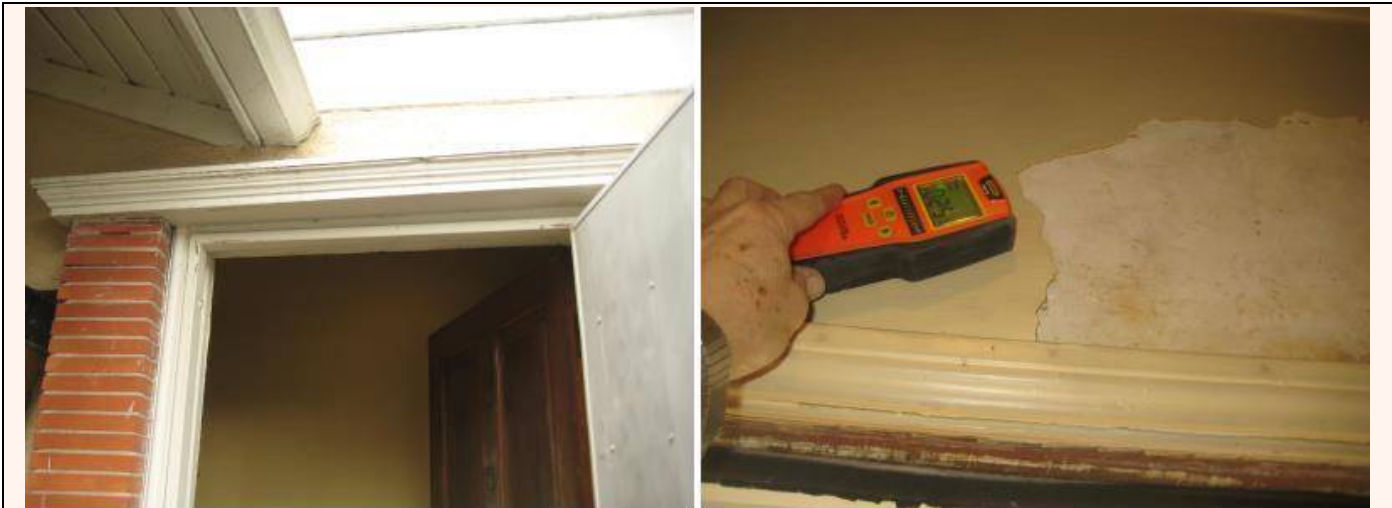
EXTERIOR DOORS:

Low level of moisture detected above door.

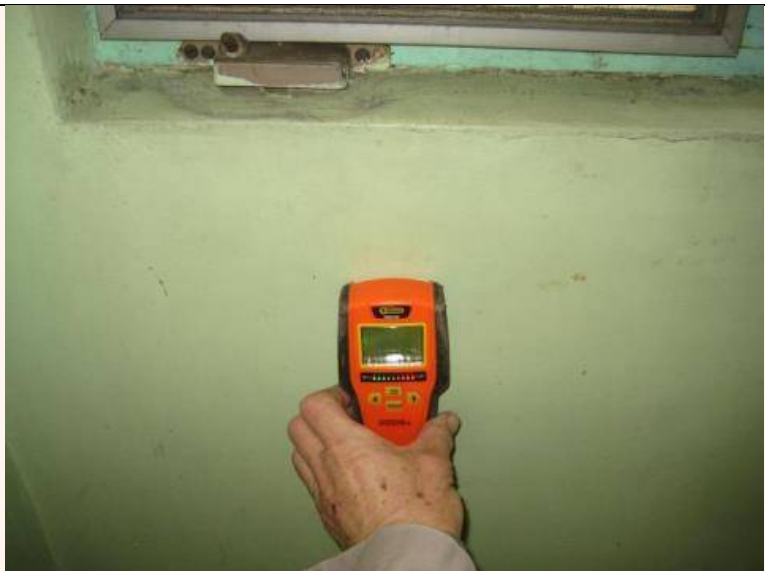
WINDOWS CONDITION:

Moisture level high under bedroom window.
Recommend wall sample or destructive investigation.
