Report: Sample Mold 12345 Sample Ave, Sample City

Confidential Mold & Moisture Inspection Report

12345 Sample Ave,
Sample City, CA 91040

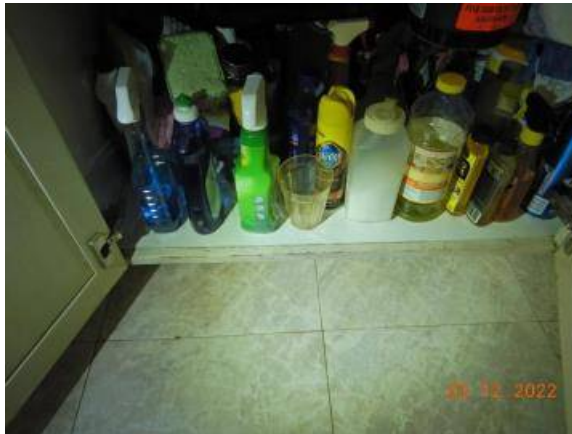
2.2 CABINETRY:

Water damage is noted within cabinet, under sink, but no other indication of any mold problem.

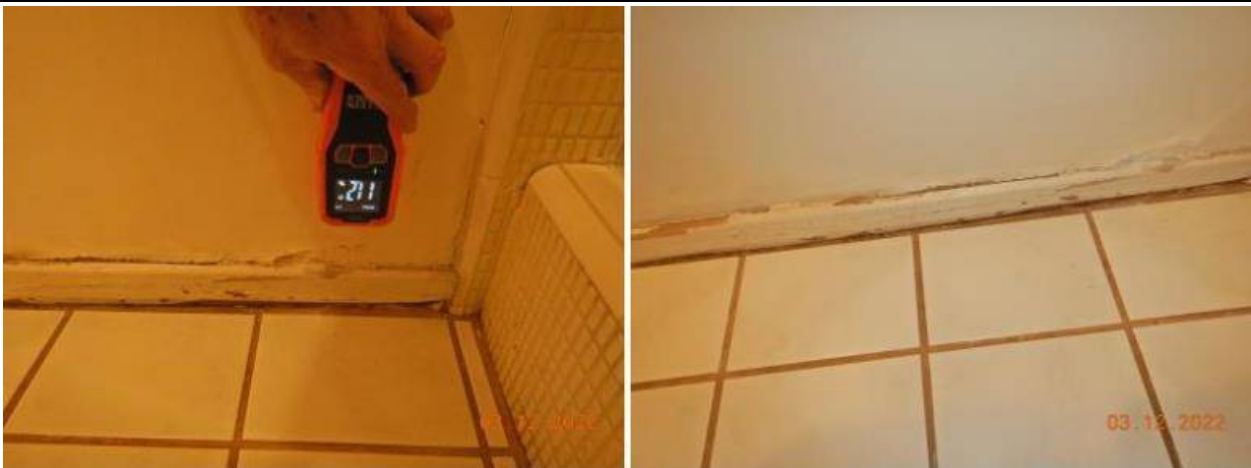
4.2 LOCATION:

Main bedroom No elevated moisture levels, mildew smells, or visible signs of mold noted.

Water damage to baseboard and wall next to and above shower stall. Moisture meter and thermal camera showed no sign of current moisture. Recommend remove and replace damaged material. No sampling necessary as the recommendation would be the same regardless if there happened to be some mold behind the baseboard.

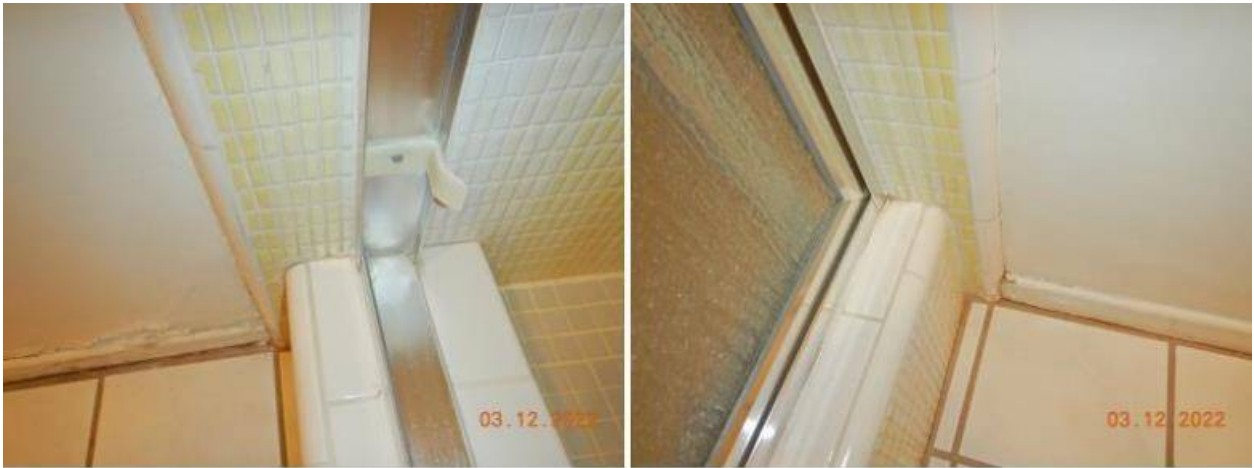
4.3

Water may be getting through the enclosure and should be sealed.

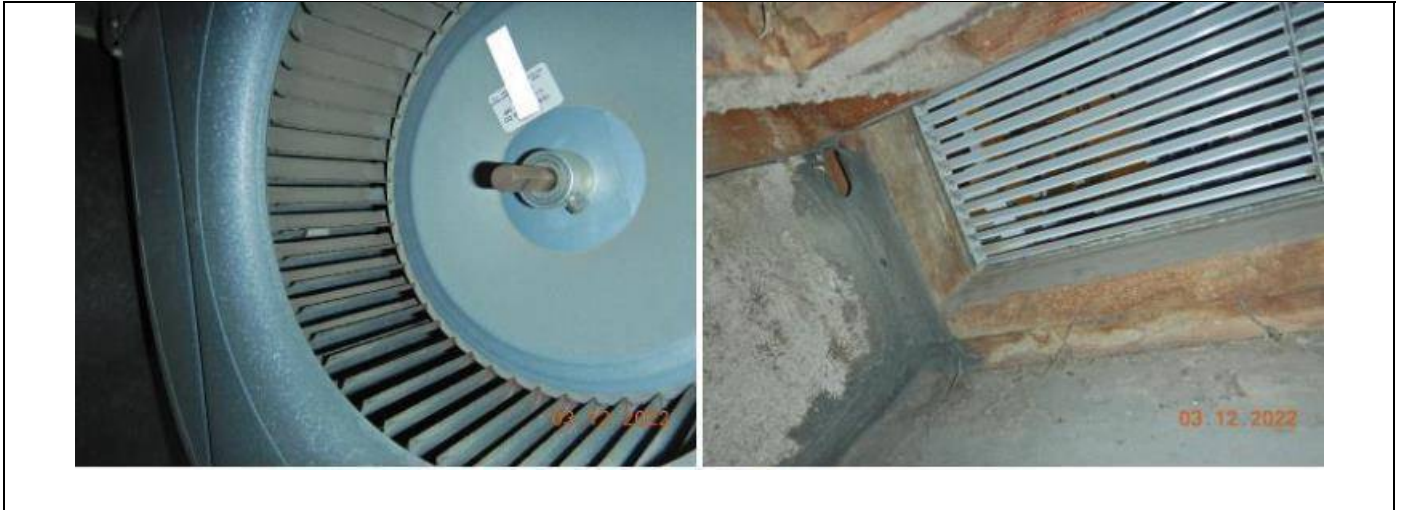
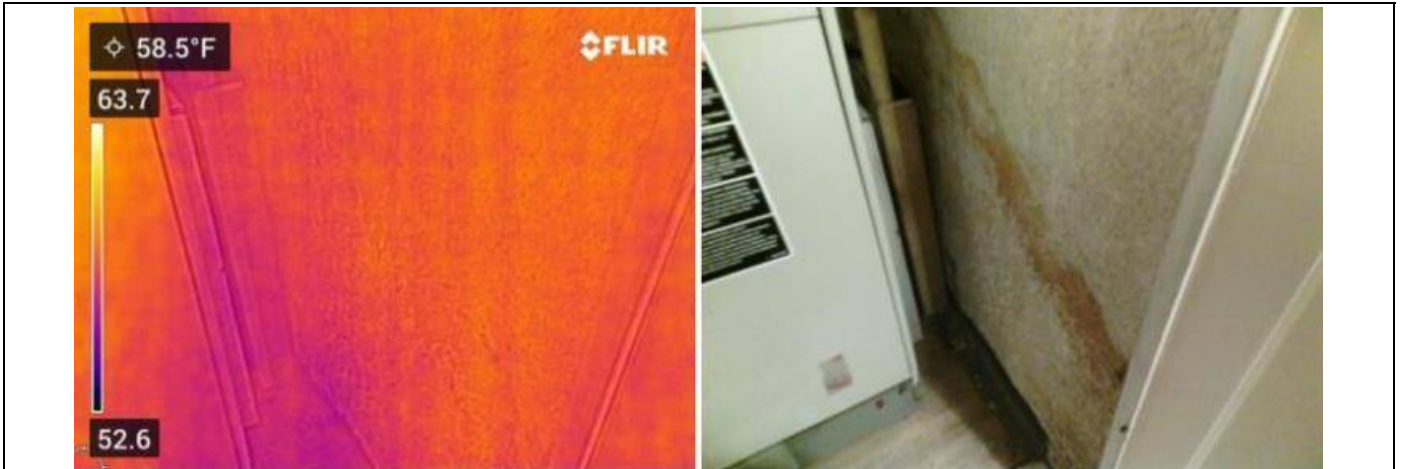
Excessive water staining in furnace closet. No evidence of current moisture. No visible mold present or mildew smells noted. Possibly asbestos acoustic material in closet which should be tested before removing.
