Report: Sample 54321 Sample St, Sample City 91040

Confidential Mold & Moisture Inspection Report

54321 Sample Street
Sample City 91040

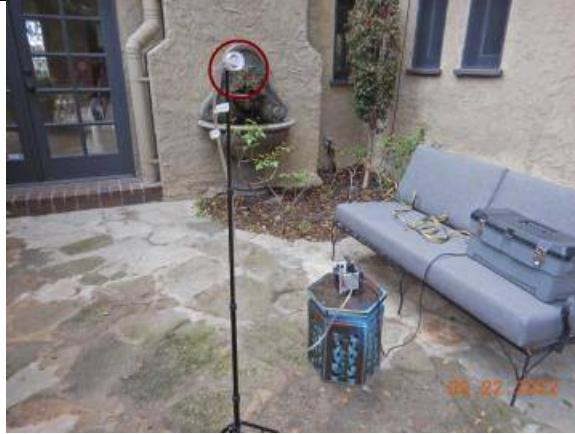
1.16 Outdoor Air Sample

An outdoor air sample was taken to help establish a base.

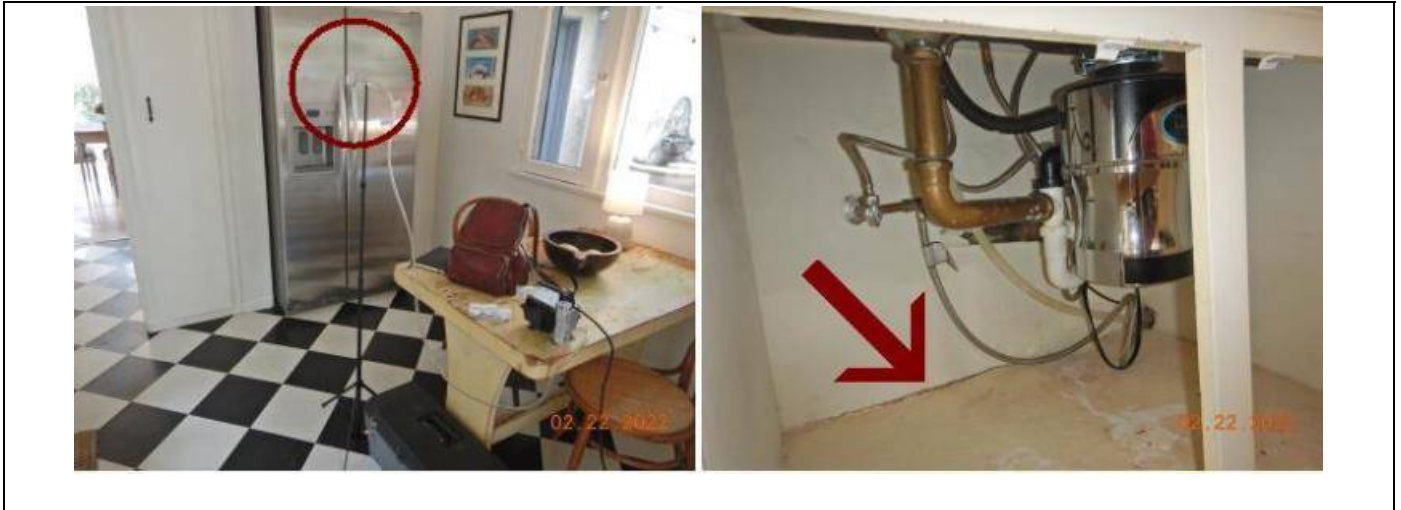
2.1 SINK & DRAIN:

Under kitchen sinks and sink cabinets are not uncommon to find old water damage, water staining, mold and mildew. This cabinet had water damage under the sink.

The kitchen air sample showed **very low levels** of various mold species, some which did not show outside.

Recommend removing the bottom of the sink cabinet for further investigation and remediation, cleaning any suspected areas found. If it appears there is more than surface mold some of the plaster may need to be removed and a visual inspection of the studs be achieved. The dishwasher should be removed as well.

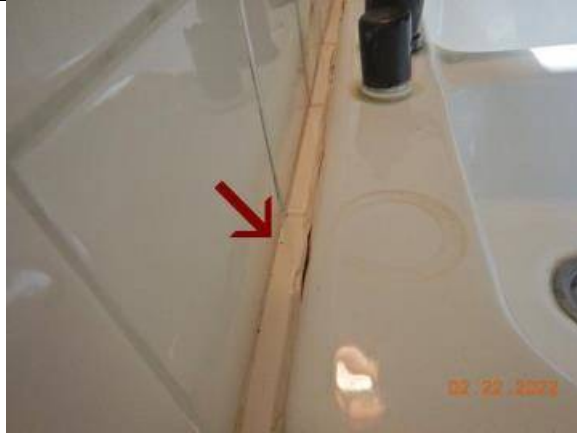
2.2 CAULKING:

Another source of the mold count could be around the sink. Black staining that appears to be moisture related under/on seal. Recommend removing existing caulk, cleaning, and replace with anti-bacterial silicone.

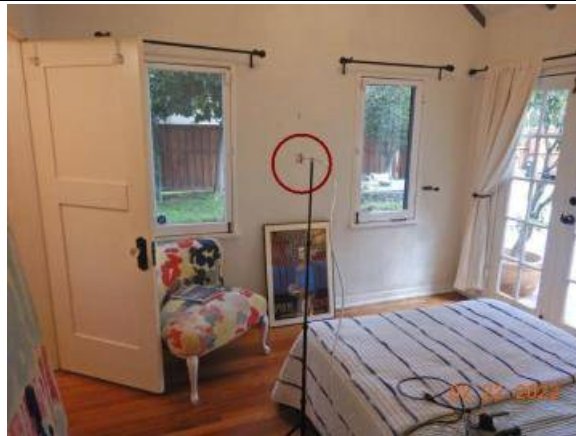
3.1 NW BEDROOM

The NW bedroom air sample showed **very low levels** of various mold species, some which did not show outside. No obvious source other than possibly the HVAC in the room.

Recommend removing the existing furniture and cleaning the room and HVAC system.

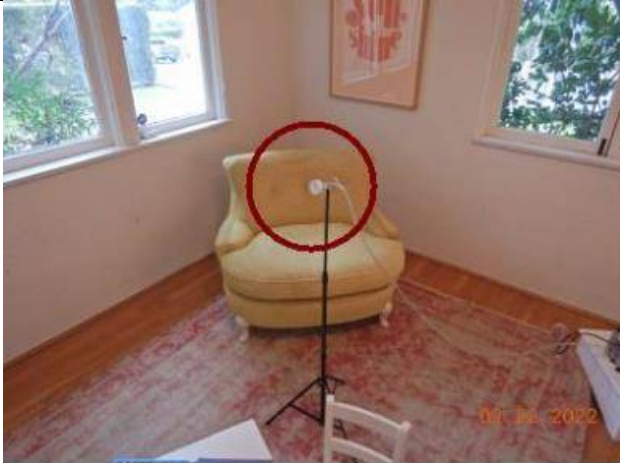
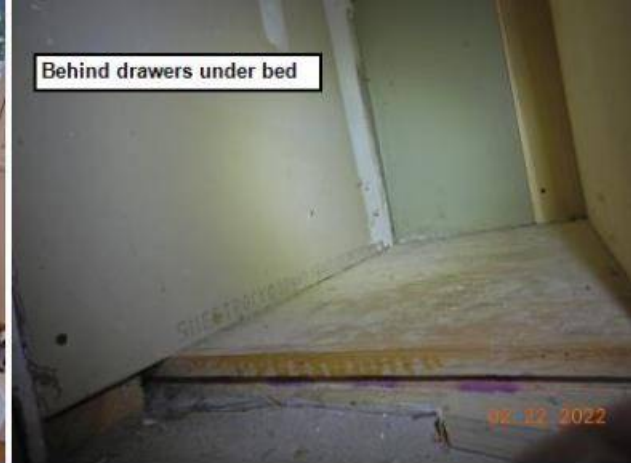
3.2 KIDS BEDROOM

The kid's bedroom air sample showed **very low levels** of various mold species, some which did not show outside. No obvious source other than possibly the visible dust under and above bed.

Recommend removing the existing furniture and drawers, and cleaning.

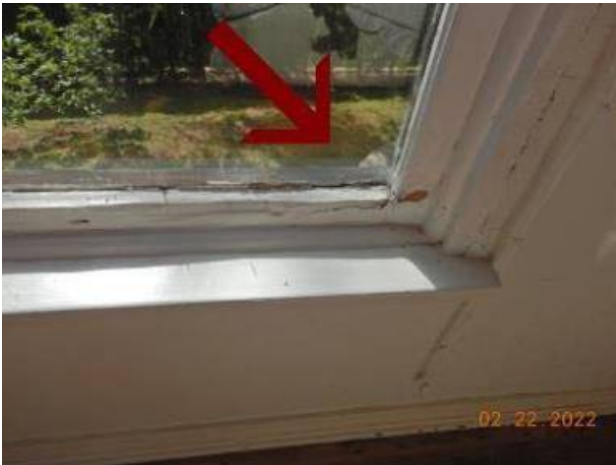
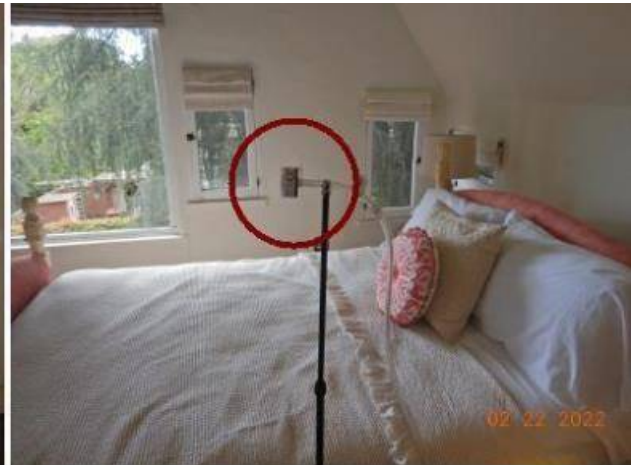
3.3 UPSTAIRS BEDROOM

Air sample showed Pen/Asp mold to be a bit above normal even for normal February outdoor levels.

Penicillium/Aspergillus levels can be found in this range (1300 spores per cubic meter), and if no water intrusion or mold issue is found during the inspection, these levels can be caused by normal life in an enclosed environment. However, it was unusual there was a spike in this particular room.

There was some water damage around the window found which may be the cause. Recommend the damage to the wood and wall be repaired and cleaned. The damaged wall should be opened to look for any visible mold and removed.

Some of the other possible sources, could be the area above the bathroom had been opened and inspected, the

furnishings along with rug and drapes, and the HVAC floor vent was visibly dirty.

Recommend removal of all furnishings and cleaning the room, clean and HEPA vac the area above the bathroom, run a duct to the exterior for the bathroom fan. With all furnishings removed, a better look of the room can be achieved and anything suspect can be cleaned or further investigated.

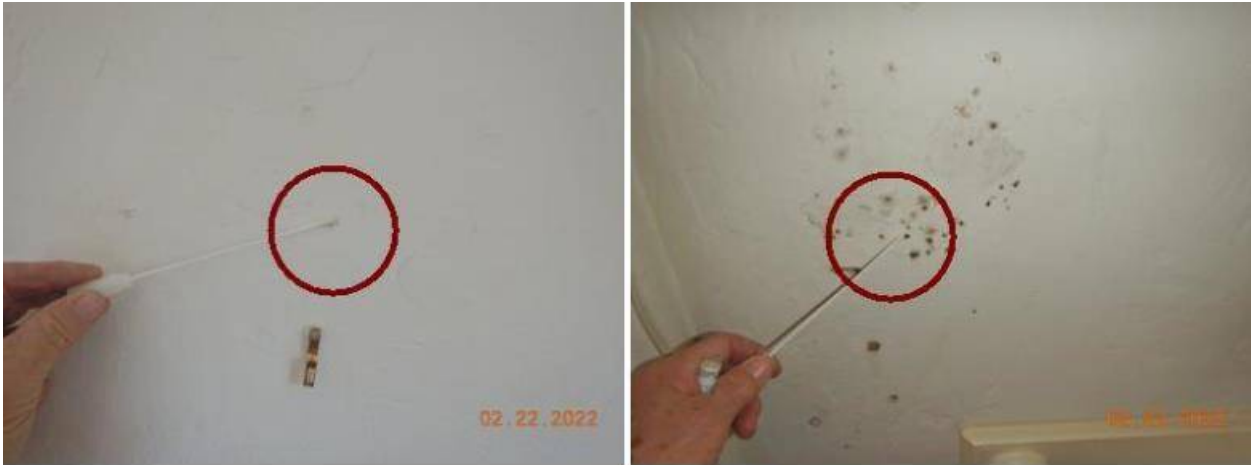
3.5 UPSTAIRS BEDROOM

The black smudges on the wall and in the closet proved to not be any type of mold and would not have contributed to the increased level of mold in the air sample.

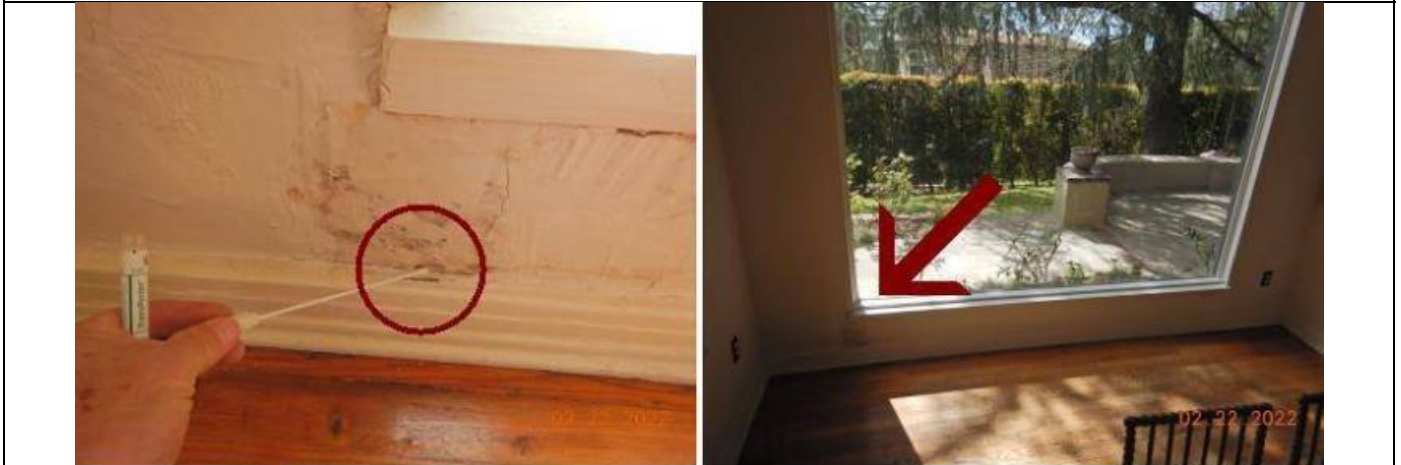
3.6 LIVING ROOM

The swab sample showed this mold to be a high level of *Ulocladium* which takes a good water source to proliferate; outside is found in the soil and decaying plants.

Recommend repairs to window, opening wall for further inspection behind the black stain. Destructive investigation starts at the obvious area and the wall is opened until no further visible mold is detected. The watering of plants just outside the window should cease or utilizing a drip system with low water plants is recommended.

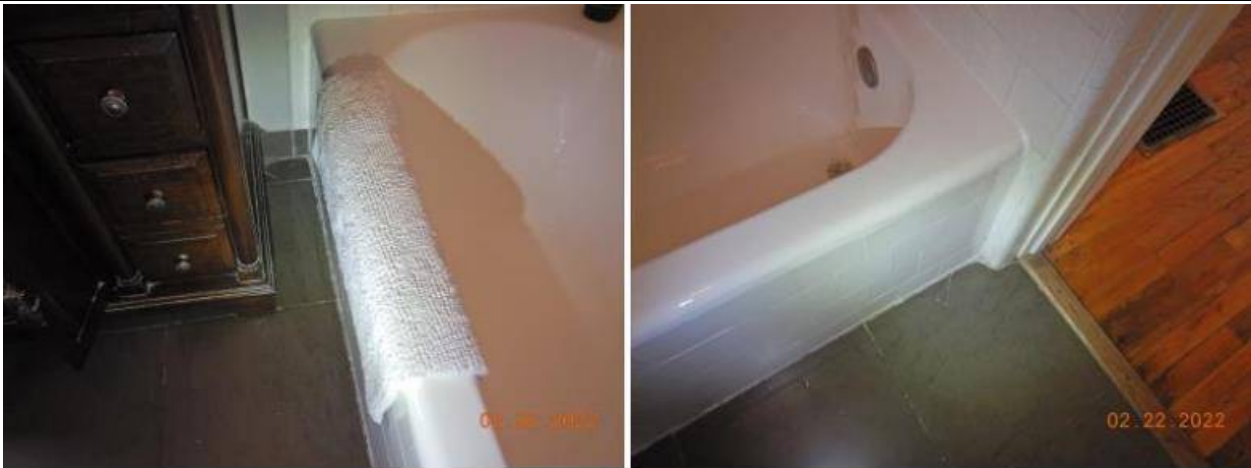
5.0

No elevated moisture levels, mildew smells, or visible signs of mold noted in either bathroom.

Areas around the tub and showers are commonplace to find water damage and mildew or mold, depending upon usage by residents. Recommend keeping areas wiped dry and humidity level down by leaving window open and/or fan on.

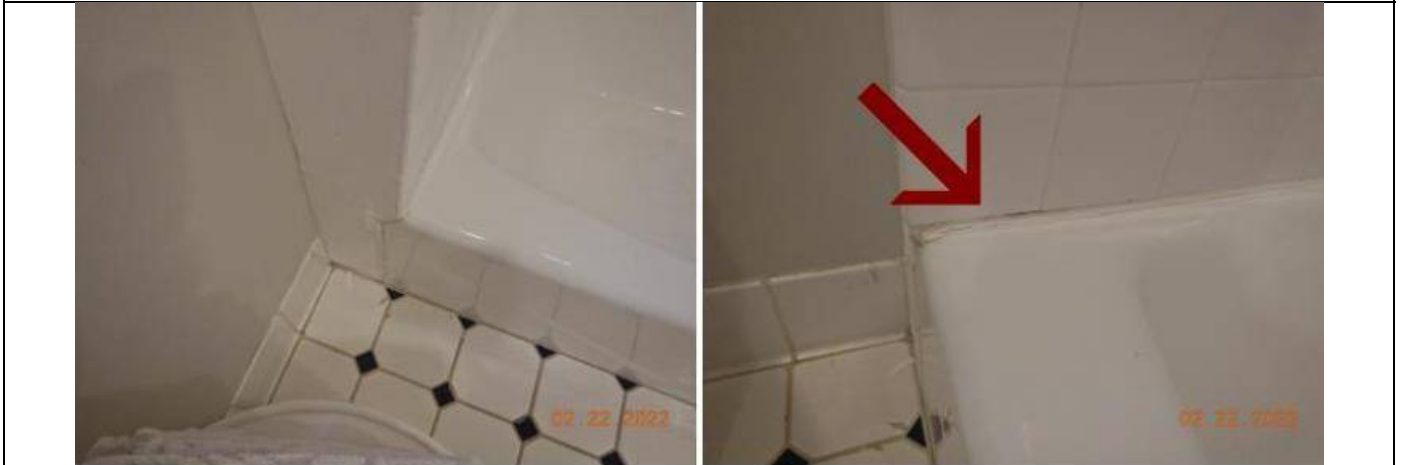
Discoloring noted under caulking which may have been mildew that was cleaned. Recommend removal and replace with an anti-bacterial silicone.

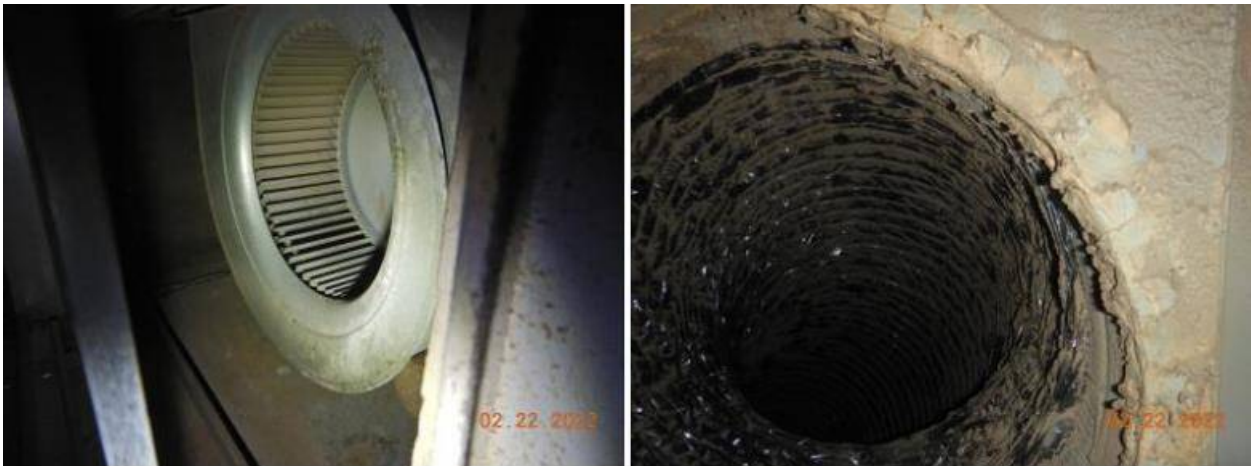
6.1 LOCATION:

System was found to be visibly dirty. ACs in general can be a source of mold due to the condensation they create and the collection of dirty air. Swab samples can be taken but the solution, if mold spores are present, would be to professionally clean and sanitize the system which should be done with this unit just based on the visible dirt.
